Advanced Tribological  
Coatings For High Specific  
Strength Alloys,  
R&D 5876-MS-01

5th Interim Report

# National Centre of Tribology

Date: 29 September 1989

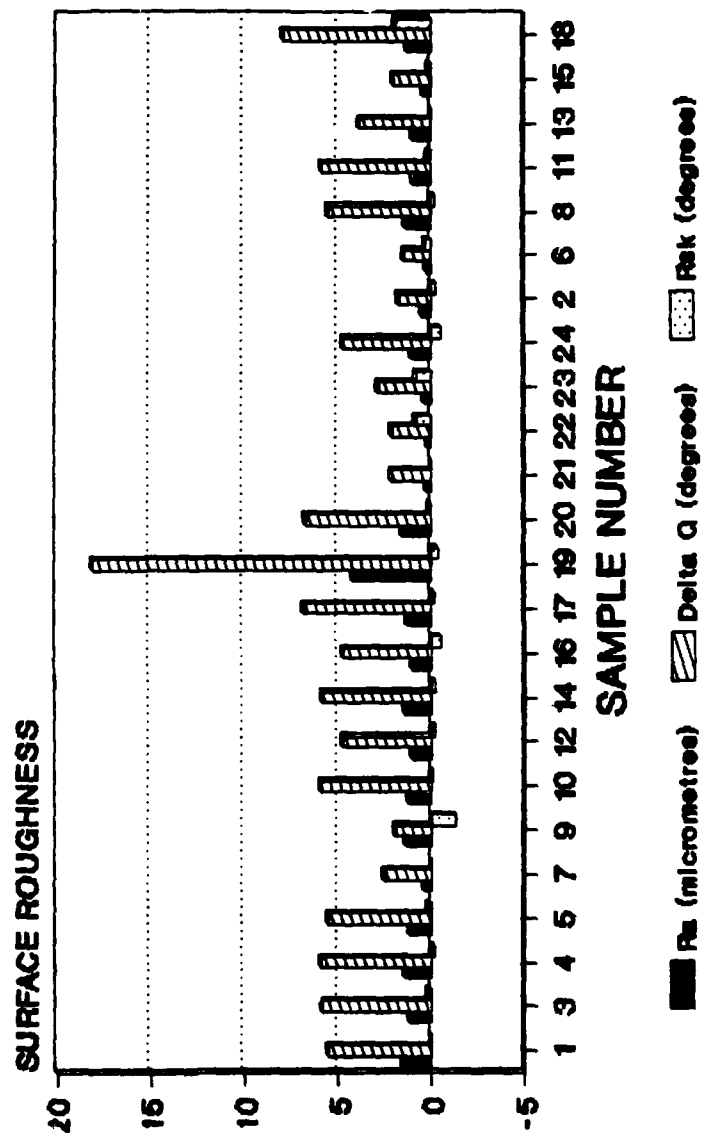
# **HSSA RECIPROCATING WEAR TESTS** **SURFACE ROUGHNESS MEASUREMENTS**

The surface roughness measurements for the samples are summarised in Figure 1. This figure has been arranged with the samples that were originally solution heat treated grouped first, followed by those which were originally hardened and ground. Essentially only pack aluminising (HSSA19) causes any detriment to the surface roughness, all other treatments either cause no change or a small improvement in the surface roughness.

For the application of dry lubricants (ie sputtered  $\text{MoS}_2$ ) onto hardened titanium alloy gears, the surface roughness is an important parameter in determining film (and hence gear life). The surface roughness of all the sample plates were, therefore, measured using a Talysurf 6 profilometer, and the values of  $R_a$ , Delta-Q and  $R_{sk}$  recorded. These parameters are defined as:

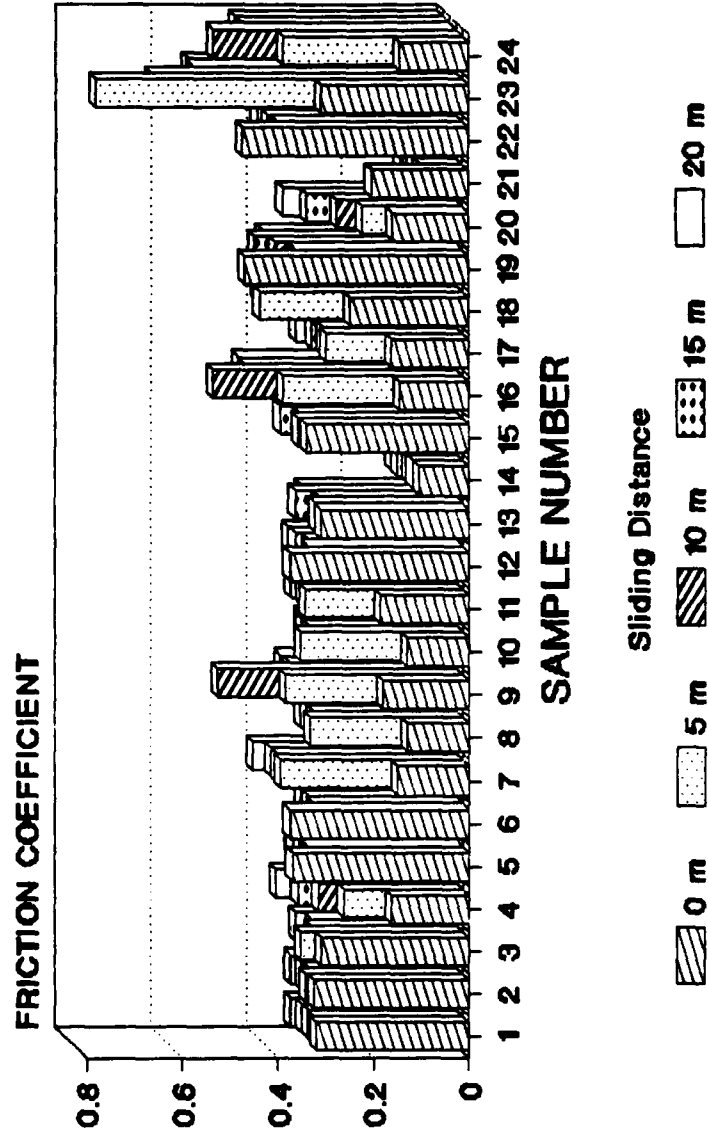
# HSSA RECIPROCATING WEAR TESTS

Figures 2 and 3 summarise the friction (at various test intervals) and the measured wear rates. The wear profiles, with attached SEM micrographs of the central region of the scars, with the exception of HSSA16, are contained in Appendix 4.

20 N LOAD, IN AIR, 1.3 GPa (MAX)

Samples HSSA1 & HSSA2 can be regarded as the baseline performance, any coating exhibiting high friction or wear can be rejected from further study. At this load samples HSSA4, HSSA10, HSSA11, HSSA14, HSSA20 to HSSA 23 show 'good' performance. The extent of the wear on HSSA4, HSSA20 and HSSA24 is not readily apparent in the micrographs attached to the wear profiles. The scars show up more clearly when viewed in back

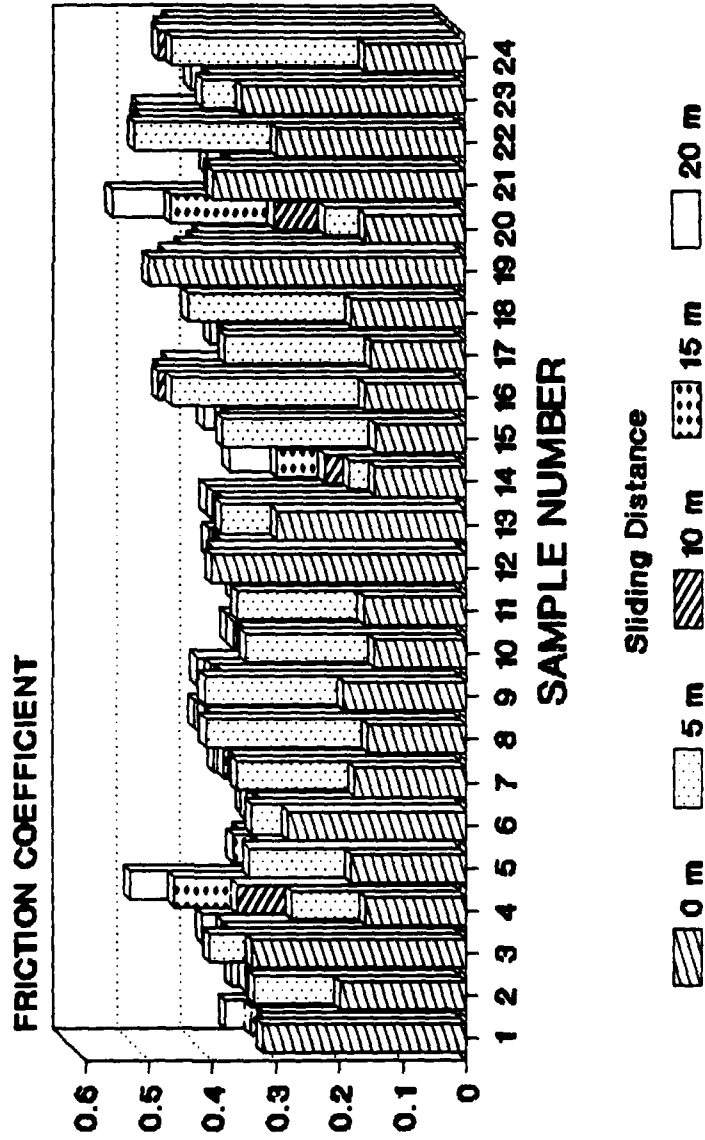
# HSSA RECIPROCATING WEAR TESTS 50 N LOAD, IN AIR, 1.76 GPa (MAX)

Figures 6 and 7 show the friction (at various test intervals) and the measured wear rates. The wear profiles, with attached SEM micrographs of the central region of the scars, with the exception of HSSA16, are contained in Appendix 5.

Samples HSSA4, HSSA14, HSSA20 & HSSA 22 give low wear rates and reasonable friction coefficients. SEM analysis revealed metal transfer from the En 31 ball to the plate occurred during the test on HSSA4 (Figure 8). A small hole can be seen in the coating of sample HSSA 22 which may indicate that the coating is starting to break up (Figure 9).

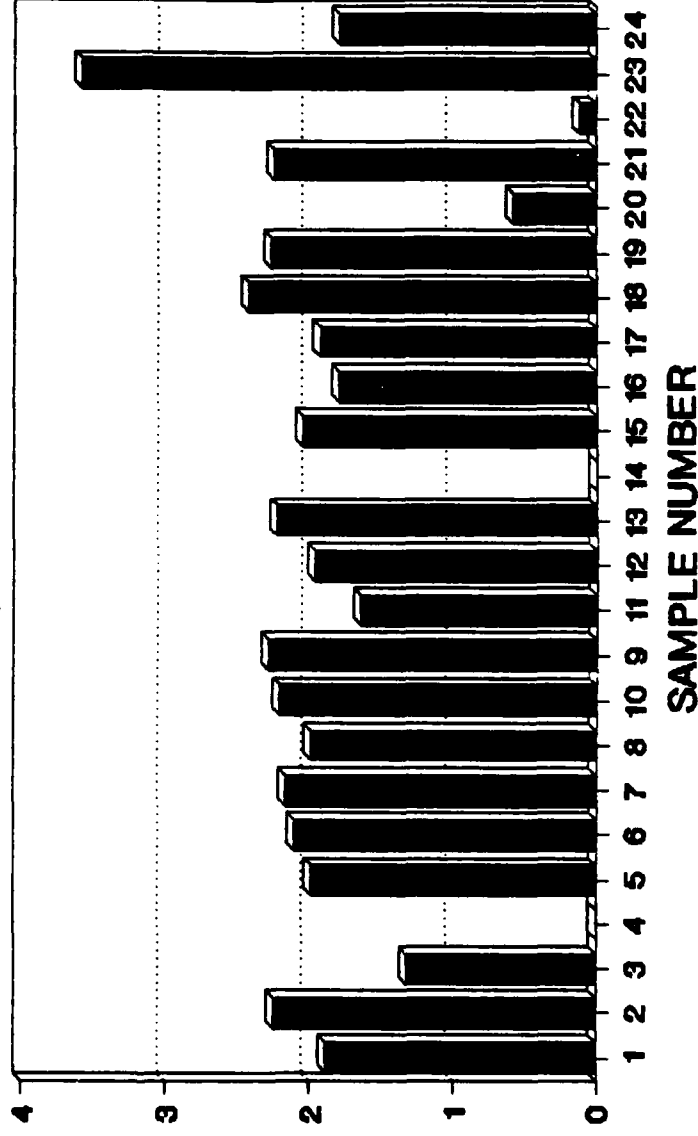
# **HSSA RECIPROCATING WEAR TESTS** **50 N LOAD, IN AIR, 1.76 GPa (MAX)**

WEAR RATE ( $\text{m}^3/\text{m}^2 \times 10^{-13}$ )

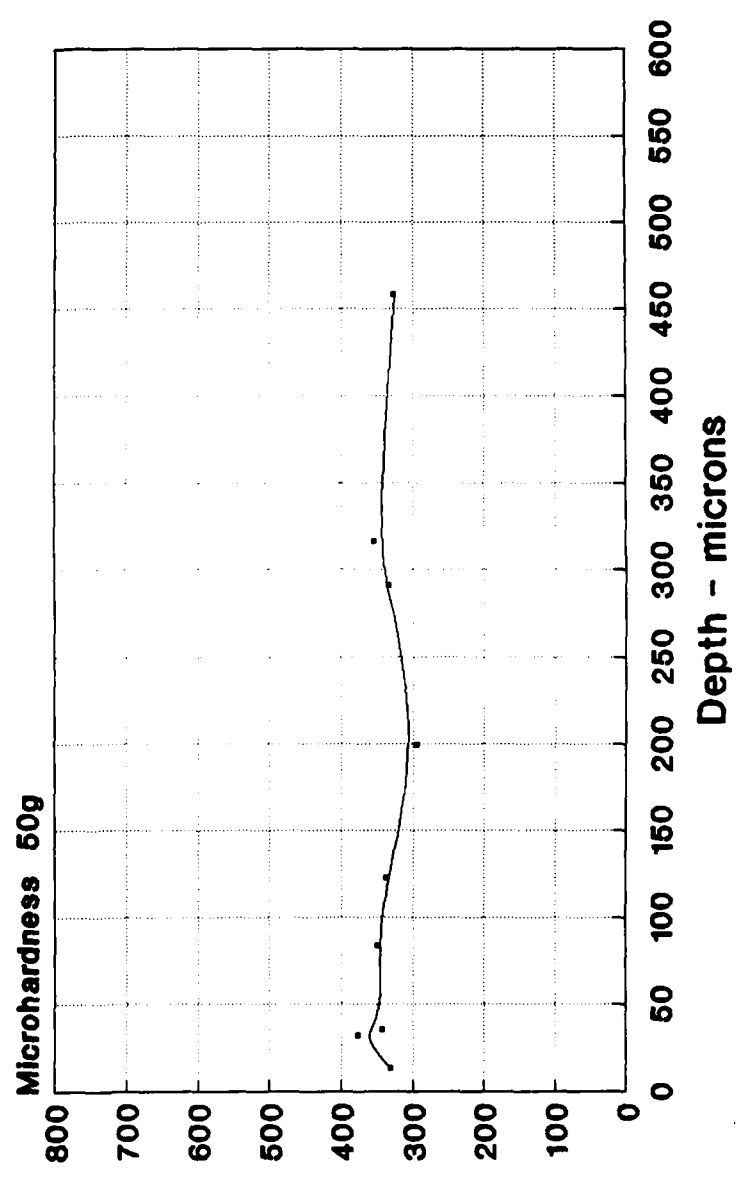
# MICROHARDNESS DEPTH PROFILE HSSA 3/ PLASMA NITROCARBURIZED #1

Microhardness depth profiles were produced by measuring the Vickers microhardness at increasing depth into the sample on the metallographic specimens. The hardness was measured by applying a load of 50N for 15 seconds. The microhardness profiles are summarised in Appendix 3.

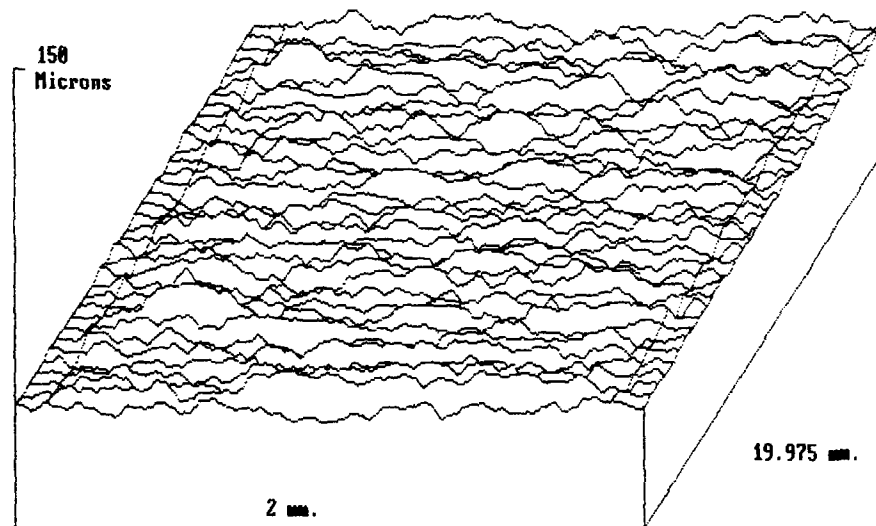
# HSSA4: Beta Nitrocarburized 1

Wear volume in cubic millimetres

Above datum	Below datum	Net loss
3.921508E-02	3.531782E-02	-3.897257E-03

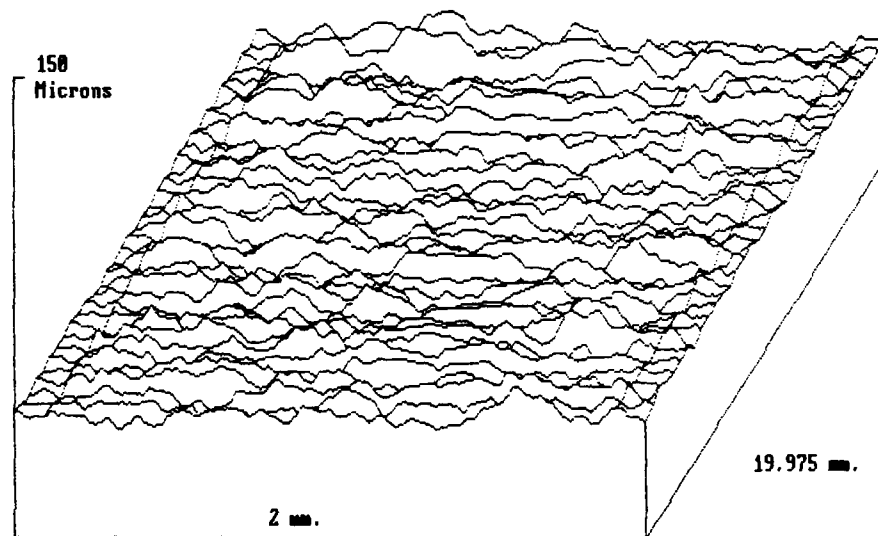
# HSSA14: High Temperature Nitrocarburized 1

Wear volume in cubic millimetres  
Above datum    Below datum    Net loss  
4.902035E-02    4.254118E-02    -6.47917E-03

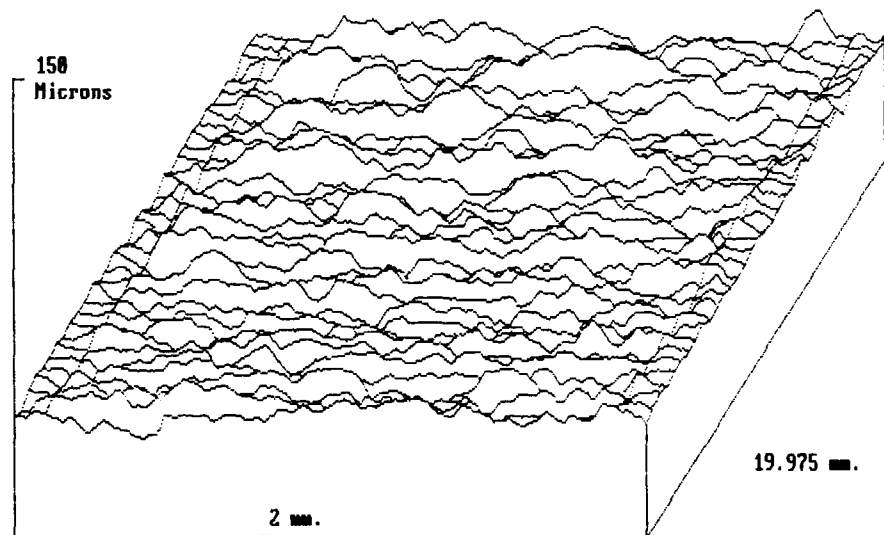
# HSSA 20: Gas Carbonitriding 1

Wear volume in cubic millimetres

Above datum	Below datum	Net loss
4.566613E-02	5.848346E-02	1.281733E-02

To date samples HSSA4, HSSA14, HSSA20 & HSSA22 show the most promising friction and wear performance. Sample HSSA20 also meets the targets for surface hardness and treatment depth

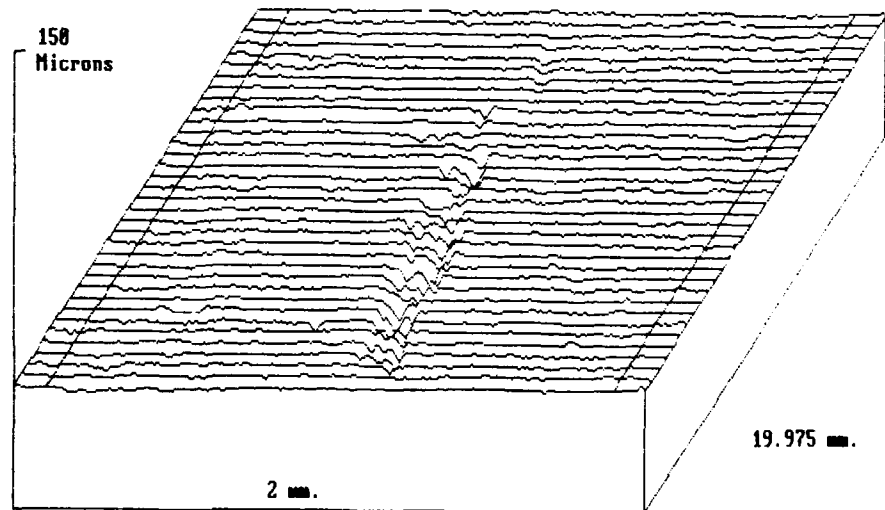
## HSSA 22: TiN Reactive Sputter

Wear volume in cubic millimetres

Above datum	Below datum	Net loss
3.728391E-03	1.470531E-02	1.097641E-02

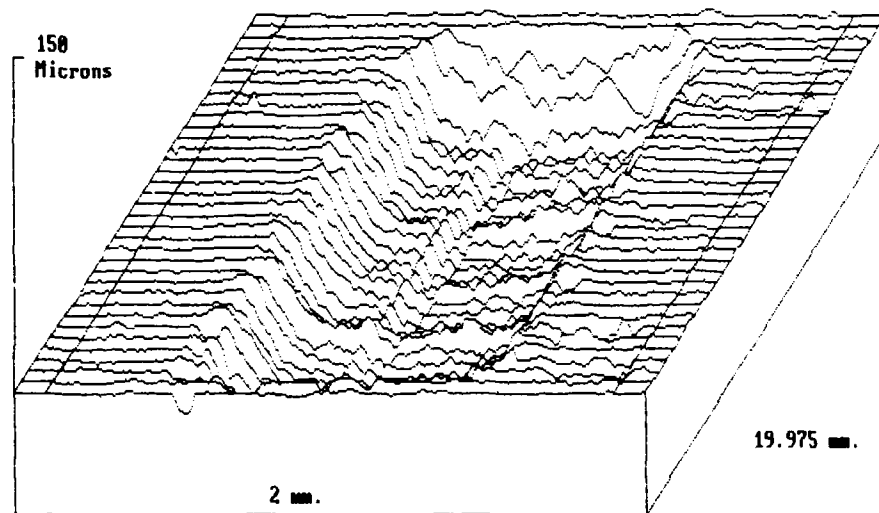
# HSSA 23: TiN/HfN Multilayer

Wear volume in cubic millimetres

Above datum	Below datum	Net loss
4.79215E-03	.3629499	.3581578

Analysis of the plasma nitrided samples (HSSA12 and HSSA13) has revealed poor processing, further samples are being prepared with a different supplier. The TiN/HfN multilayer (HSSA23) probably failed at 50N because substrate could not support the coating (cf ice on mud). The wear rate for this treatment is greater than that for uncoated titanium because of the presence of TiN and HfN particles in the wear debris. These are very hard and effectively improve the cutting properties of the En30 ball. Multi-treatment (e.g. Nitrocarburize then TiN/HfN multilayer) would result in support for the film and improved results. This approach is being evaluated.
